## Acid Sulfate Soils in the LMRIA

Issued February 2013

*EPA 05/18825: This factsheet summarises the acid sulfate soils issue in the LMRIA and the involvement of the EPA in its management.*

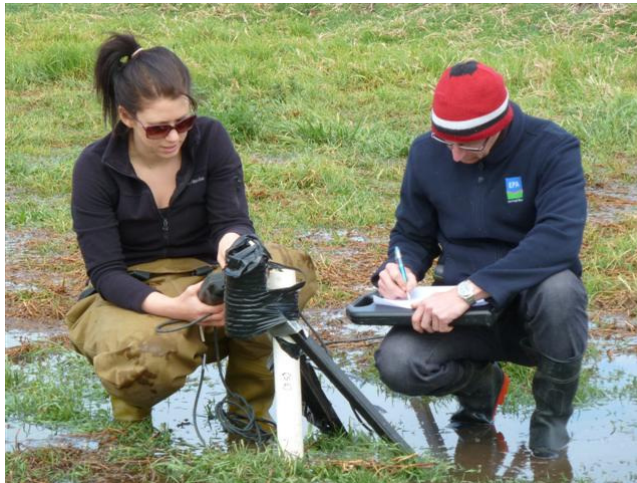
Figure 1. EPA Officers testing the quality of shallow groundwater

- Monitors each of the 14 acidic drains on a fortnightly basis to gather data about the level of acidity and metals present in the drains (Figure 1). This gives a good indication of what is being discharged to the River Murray

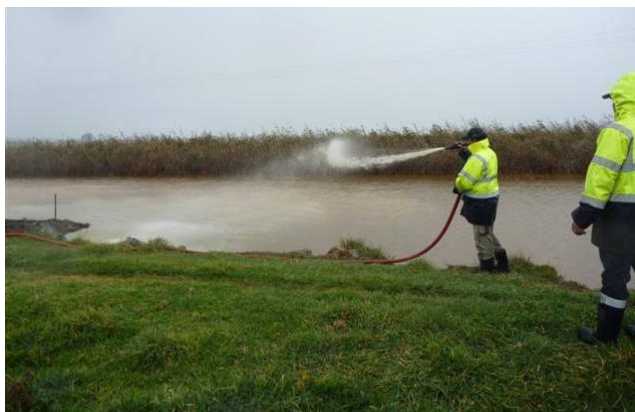
This trial at Jervois Irrigation Area treated the acidic water in the drainage channels by introducing a neutralising limestone slurry prior to discharge to the River Murray (figure 2). Results showed that the acidic drainage is able to be successfully treated using this method. A neutral pH was achieved and acidity and associated soluble metals were reduced to acceptable levels before discharge to the River Murray. Although this is an effective and efficient method of neutralising acid drainage water prior to discharge, it is expensive, and does not treat the problem at the source (i.e. in the soils under the irrigation bays). This treatment method would have to be in place at each LMRIA discharge for a long time period and fails to address the potential build up of metal precipitates within the drains.

Figure 2. Limestone dosing undertaken by the EPA

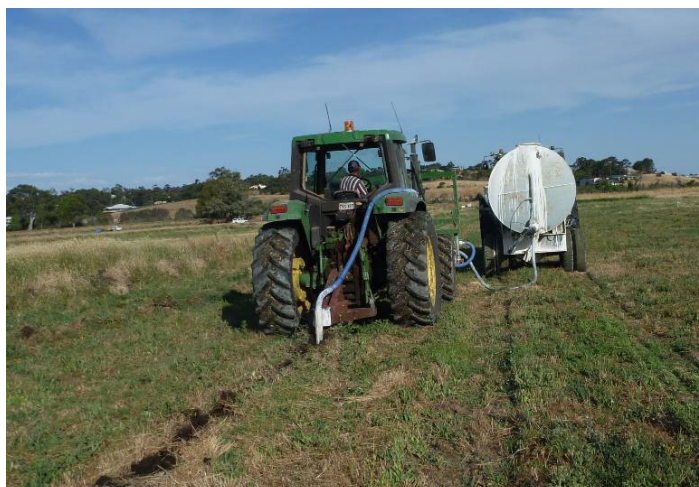
This trial introduced a neutralising material (lime slurry) into the subsoils by using a mole ploughing technique common to the LMRIA area (Figure 3). The mole plough was originally used in the LMRIA to form gravel lined channels to assist drainage in clay soils. In this trial, the lime slurry was used in place of the gravel in the mole drain. By using this method, the neutralising material was delivered directly to the sub soil and the zone of acidity (700mm below ground), without disturbing the pasture or topsoil. By creating pockets in the soils profile where the acidic groundwater and soil can be neutralised, it is hoped that the process of remediation can begin in these soils.

The trial has been conducted in the Mobilong Irrigation Area, a retired site owned by SA Water. Two paddocks were used in the trial, one as the mole plough trial site and one as a control. The mole ploughing was undertaken to a depth of 700mm in several parallel lines along the length of the paddock. Ploughing was followed by a series of irrigation events, which helps to spread the lime in the sub soils. This method has been undertaken over two stages. The first trial of this method was undertaken in October 2012 when 1,000 kg of lime was injected into the test paddock and a more intensive trial in December 2012 (6,000 kg of lime injected into the same paddock). Regular monitoring has been conducted to measure changes in acidity in the soil. Results are still under evaluation.

Figure 3. Mole plough trial being undertaken at the Mobilong irrigation area
